UNITED STATES ENVIRONMENTAL PROTECTION AGENCY

MEMORANDUM

SUBJECT: CertainTeed Transite Pipe Plant, St. Louis, Missouri,
Site Asbestos Evaluation, 12/17/92 (SBR19)

FROM: Paul E. Beatty *Paul E. Beatty*
Environmental Engineer, AMON/EMCM/ENSV

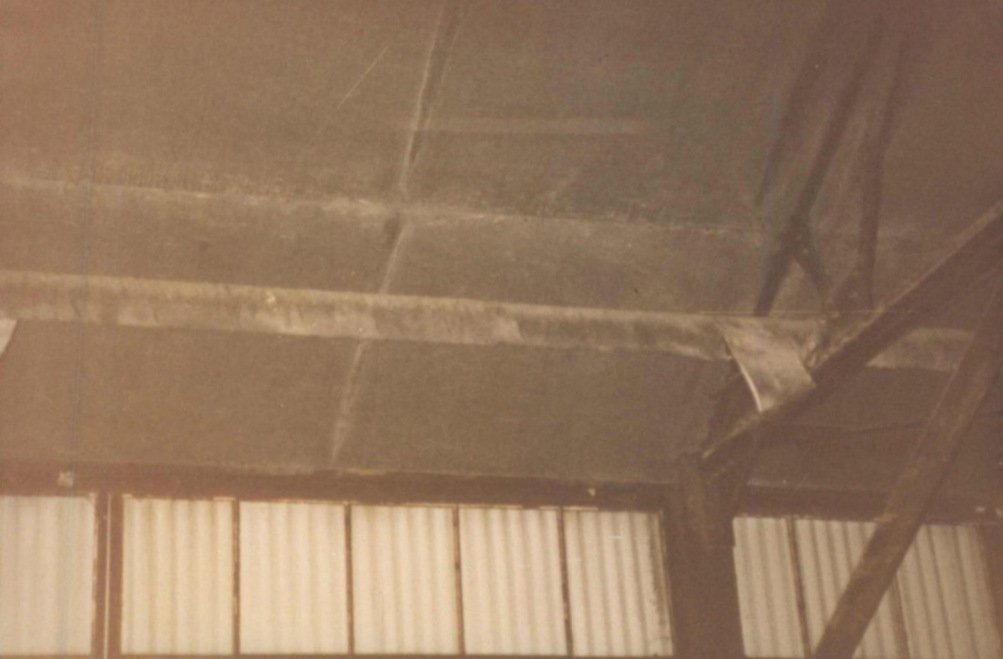
Photo #1

CAPTION: Northeast building, Area C.

4" diameter pipe, covered with thick cloth-type
insulation.

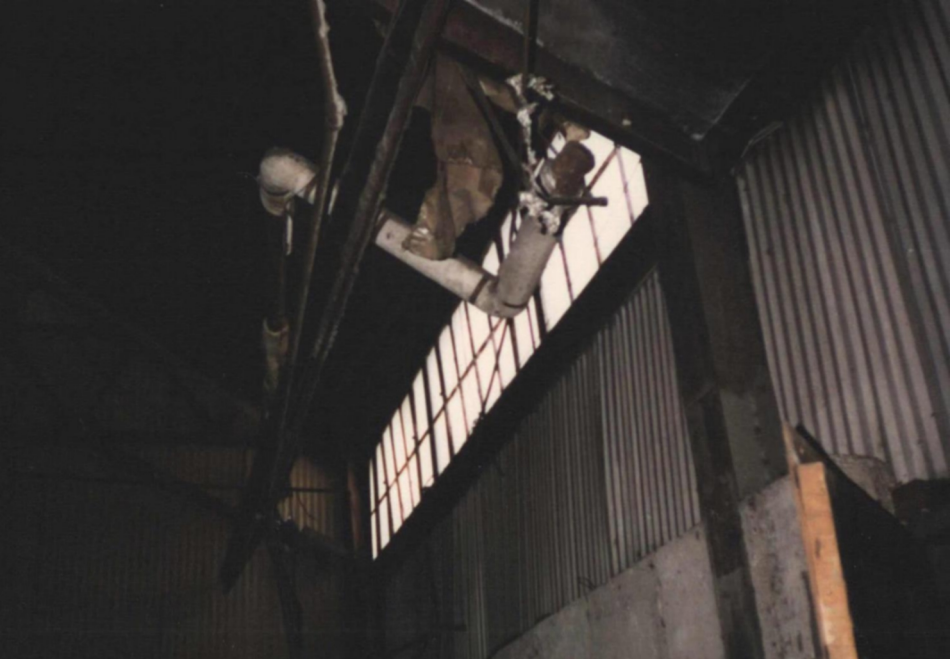
Photo #3

CAPTION: Northeast building. Area C.
Pipe with deteriorating pipe insulation.

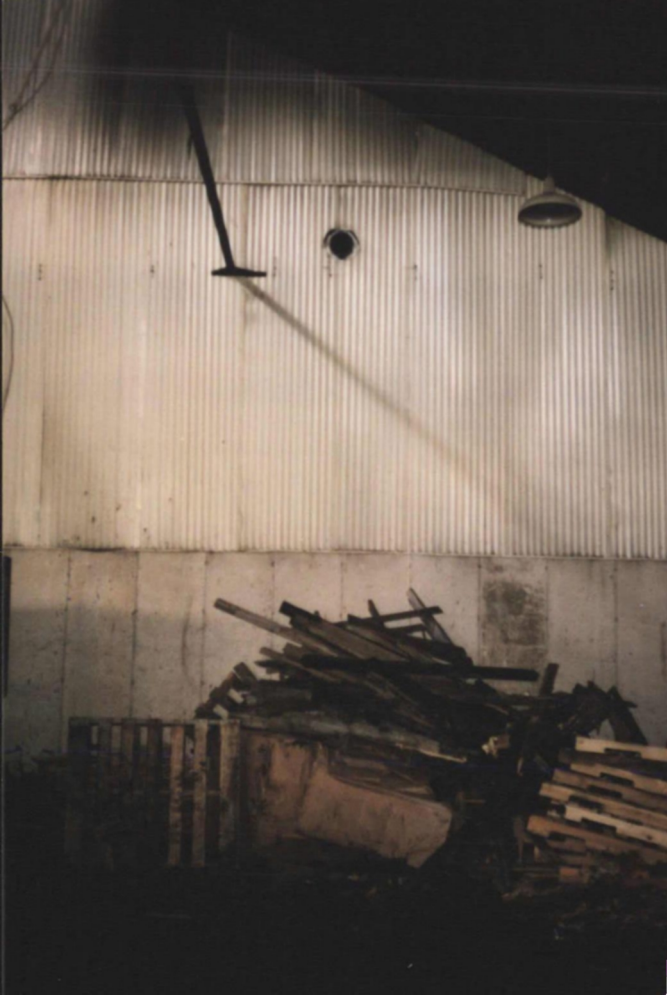
Photo #11

CAPTION: Northeast building. Area B.
Northwest wall.

Note: Cutoff insulated pipe.

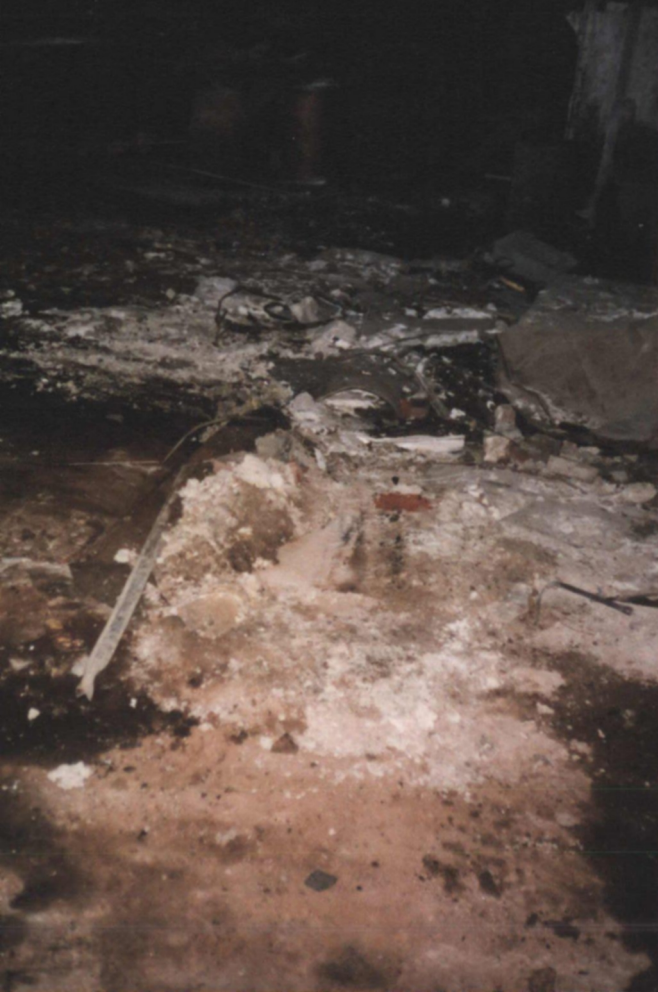
Photo #13

CAPTION: Northeast building. Area B.
Disturbed ACM.

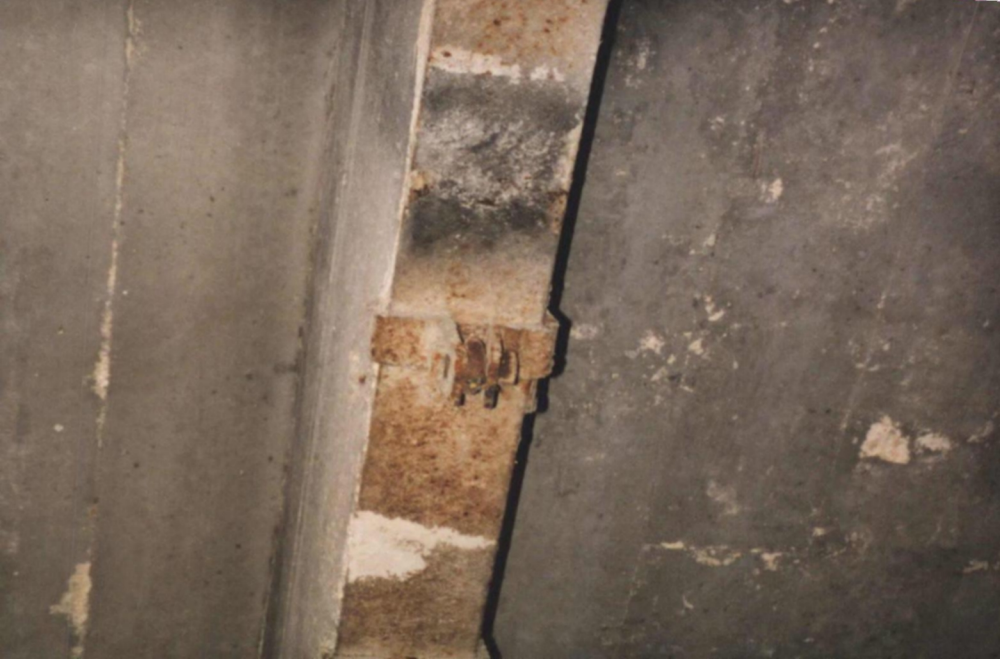
Photo #16

In area A of the northeast building, there were cutoff metal hangers suspended from the first floor and second floor ceilings. The cut metal hanger's surface was metallic in appearance, clean and not rusted like the rest of the metal hanger's surface. The metallic appearance might indicate that they had recently been cut. On the first story floor, directly below the line of cut hangers, there were four areas of chunks of block-type insulation. The four areas of insulation follow the line of cut hangers. The width of the building is about 150 feet and the cut hangers extended almost the entire width of the building on both the first and second floors.

CAPTION: Northeast building, area A, 1st Floor.
Cut metal hanger.

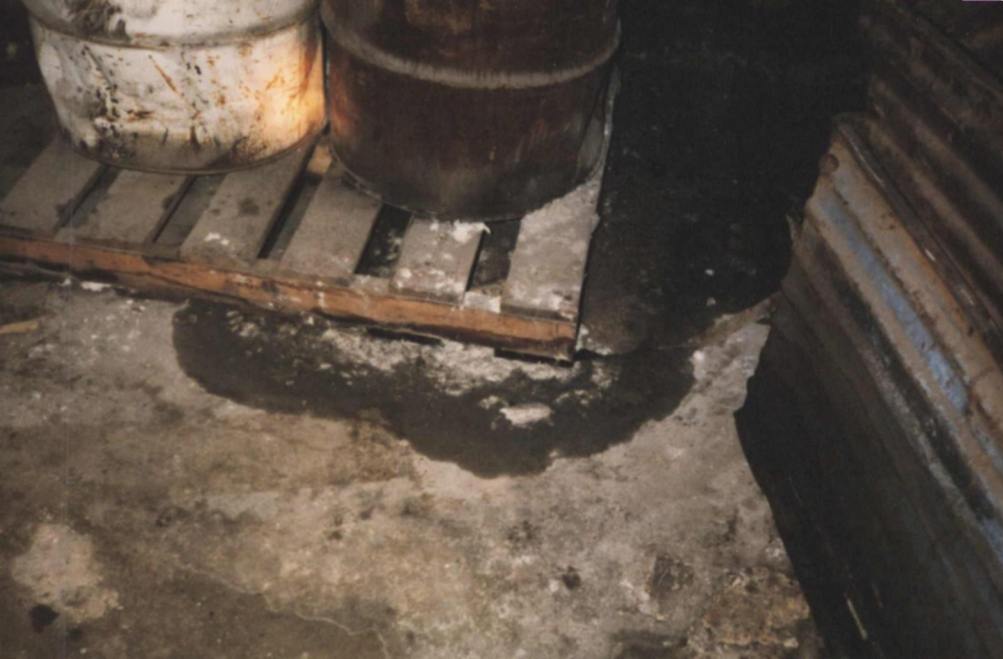
Photo #17

CAPTION: Northeast building, area A, 1st floor.
Sample Site SBR31-001. On the floor below cut
hanger in Photo #16.

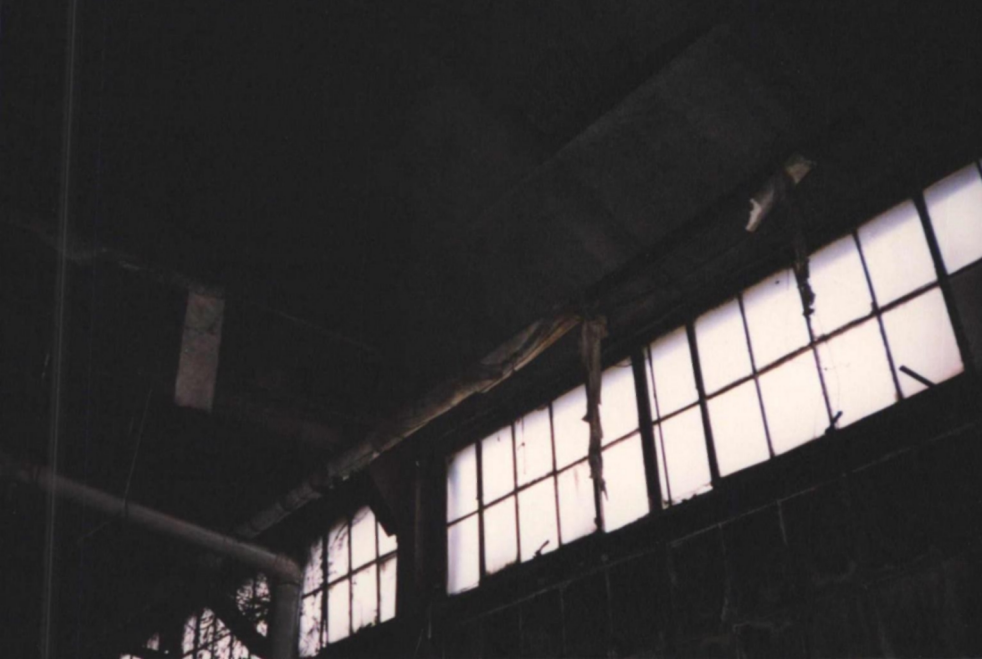
Photo #22

Pipe covered with deteriorating insulation.

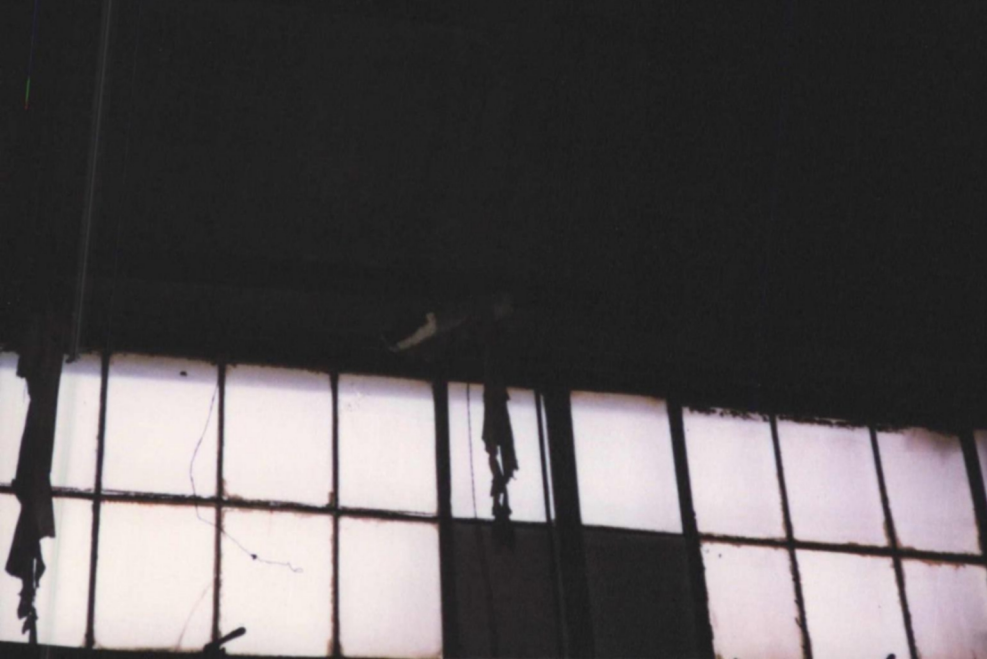
Photo #23

CAPTION: Northeast building, area B.

Same insulated pipe as in Photo #22.

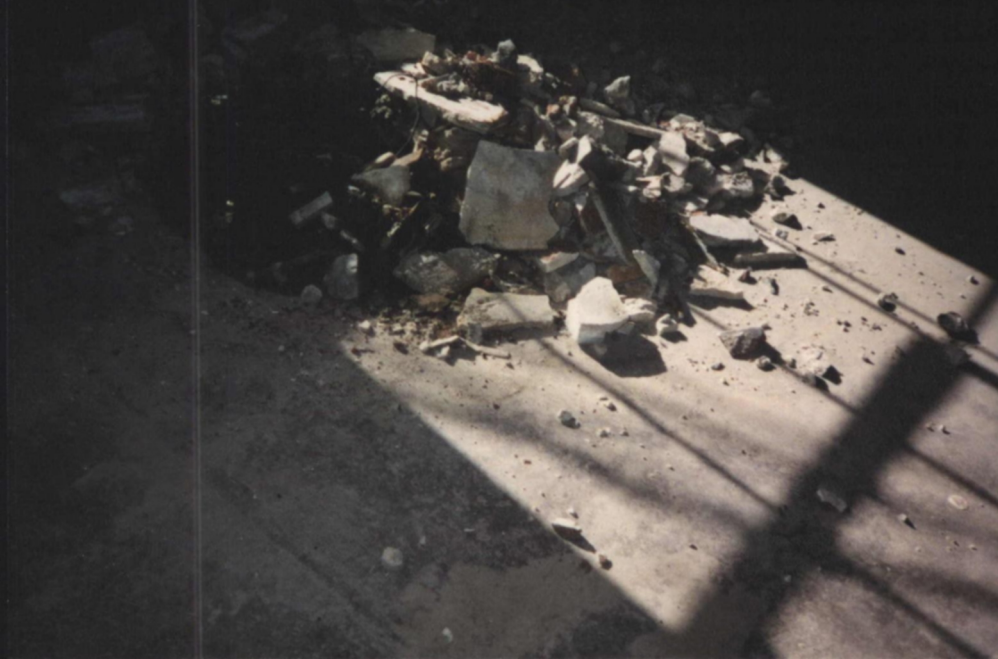
Photo #27

CAPTION: Northeast building, area A, 2nd floor.
Sample site SBR31-003.

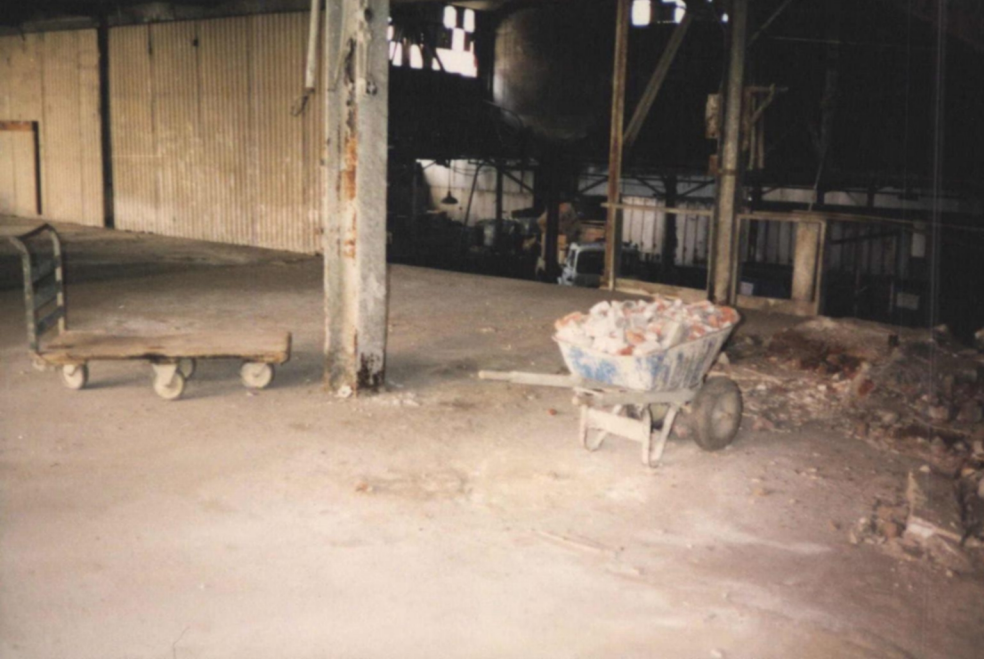
Photo #30

Sample site SBR31-004 from material on post.

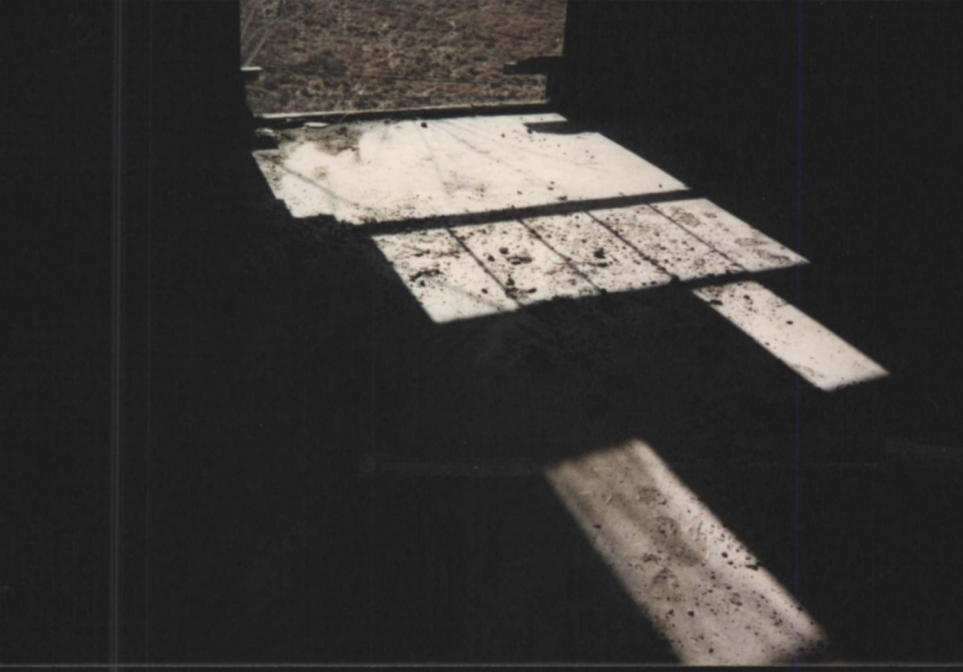
Photo #34

CAPTION: Northeast building, area A, 3rd floor.
Opening in southeast wall.

Note: Debris pushed towards opening.

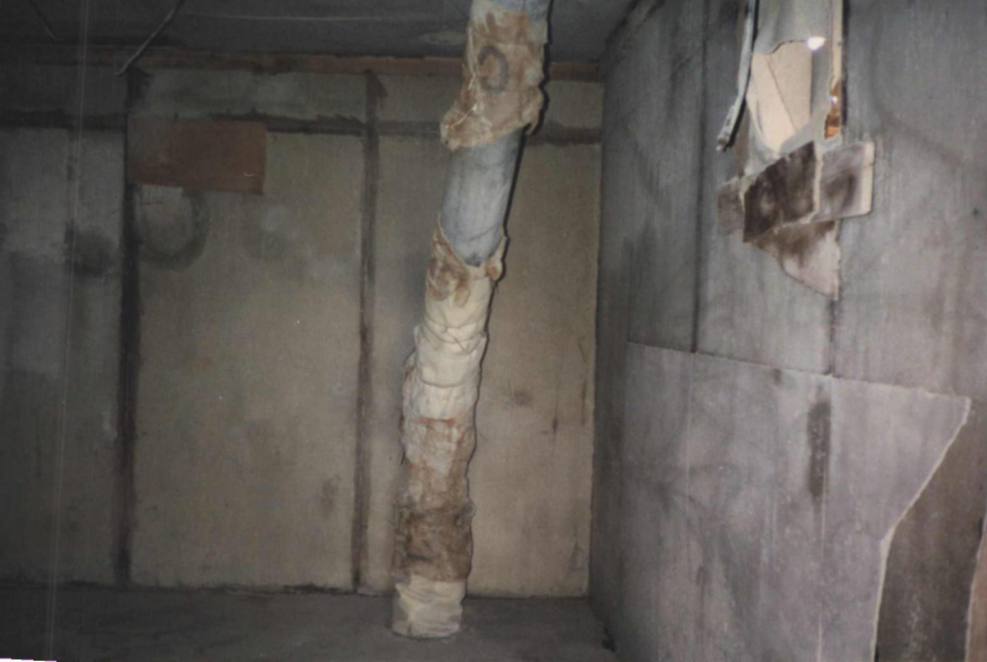
Photo #41

CAPTION: Northeast building, area A, 3rd floor.
Large pipe with felt insulation.

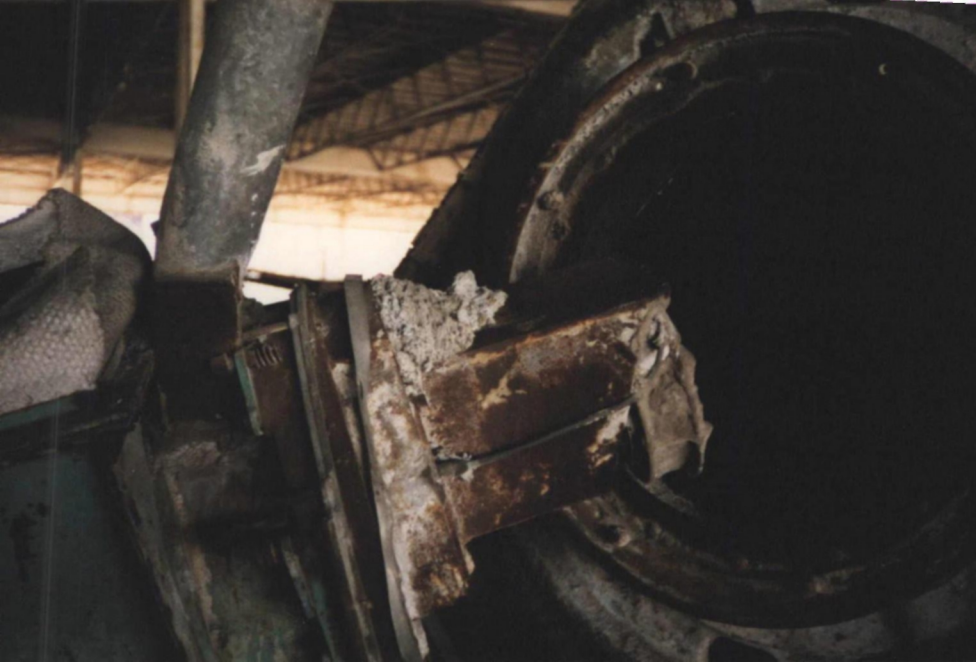
Photo #48

Located on the 2nd floor deck was a mixing tank which appeared to contain transite residue. Around the access door hatch was over 12 cubic inches of gray friable material. Sample SBR19-006 was obtained from this material. The sample was gray, fibrous and friable. PLM analysis showed the sample to contain 15% chrysotile and 3% crocidolite asbestos. The crocidolite might be indicative of transite. Crocidolite was also found in samples taken from transite pipe debris along Maline Creek on 10/29/92.

CAPTION: Southwest building, covered area.

Sample site SBR31-006 from mixing vessel.

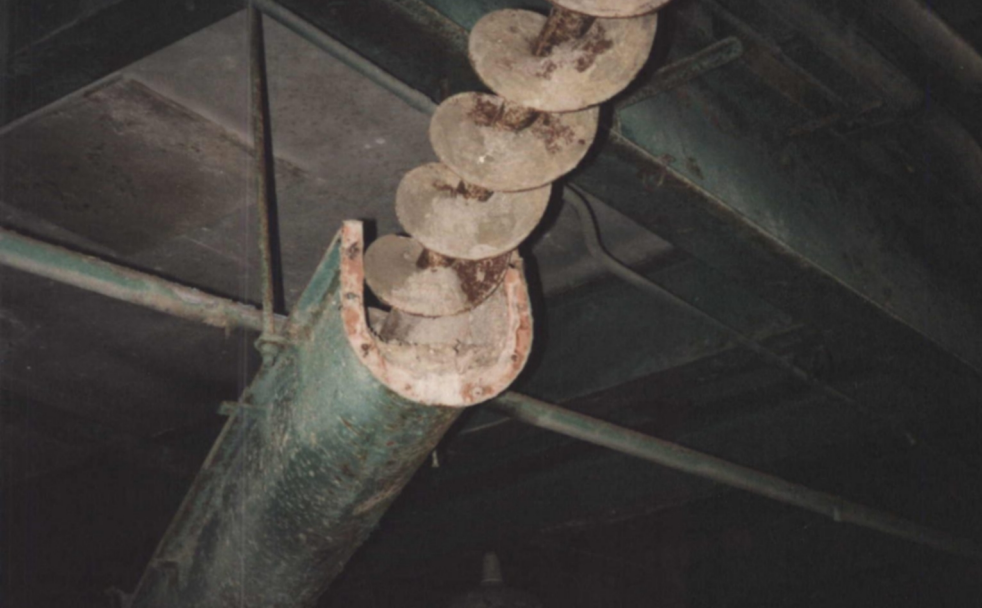
Photo #55

CAPTION: Southwest building.
Transite debris in auger.
